INDOOR AIR QUALITY ASSESSMENT

**Early Learning Center
25 School Street
North Attleborough, Massachusetts**

Prepared by:
Massachusetts Department of Public Health
Center for Environmental Health
Emergency Response/Indoor Air Quality Program
March 2006

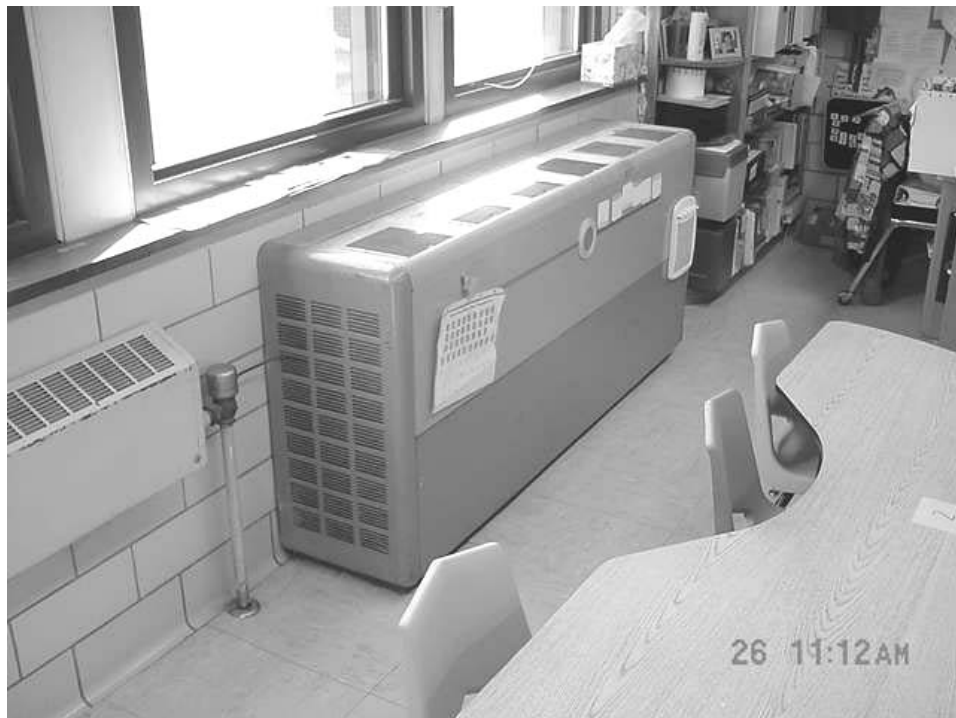
Picture 1

It can be seen from Table 1 that carbon dioxide levels were below 800 parts per million (ppm) in all areas surveyed, indicating adequate air exchange. Fresh air in classrooms is supplied by a unit ventilator (univent) system (Pictures 1 and 2). Univents are designed to draw air from outdoors through a fresh air intake located on the exterior walls of the building (Picture 3) and return air through air intakes located on the sides of each unit (Picture 1). Fresh and return air are mixed and filtered, then heated and provided to classrooms through an air diffuser located in the top of the unit ([Figure 1](#)). Univents have fan control speeds of low, medium or high (Picture 4). All univents were operating and appeared to be in good working order during the assessment. Obstructions to airflow, such as papers and books stored on univents and furniture in front of univent returns, were seen in several classrooms (Picture 5). In order for univents to provide fresh air as designed, they must remain free of obstructions.

Classroom Univent 1950's Vintage, Note Return Vents on Sides of Unit

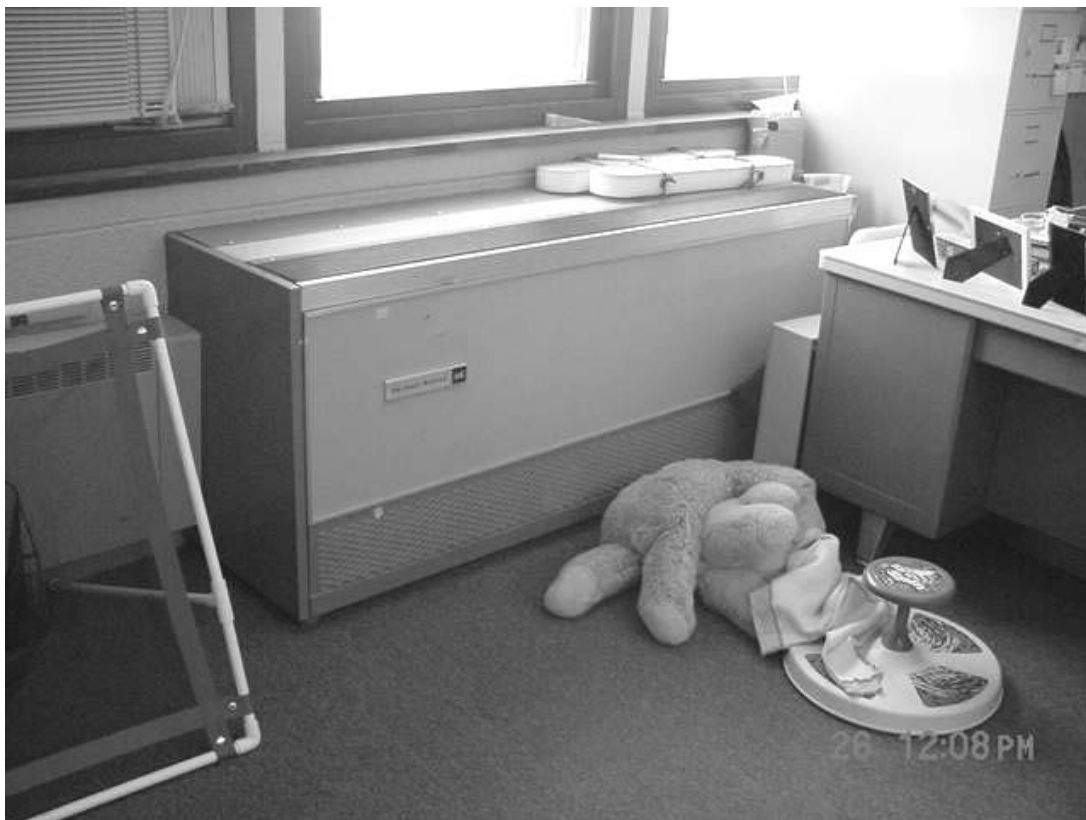
Picture 2

1960's Era Univent in Addition

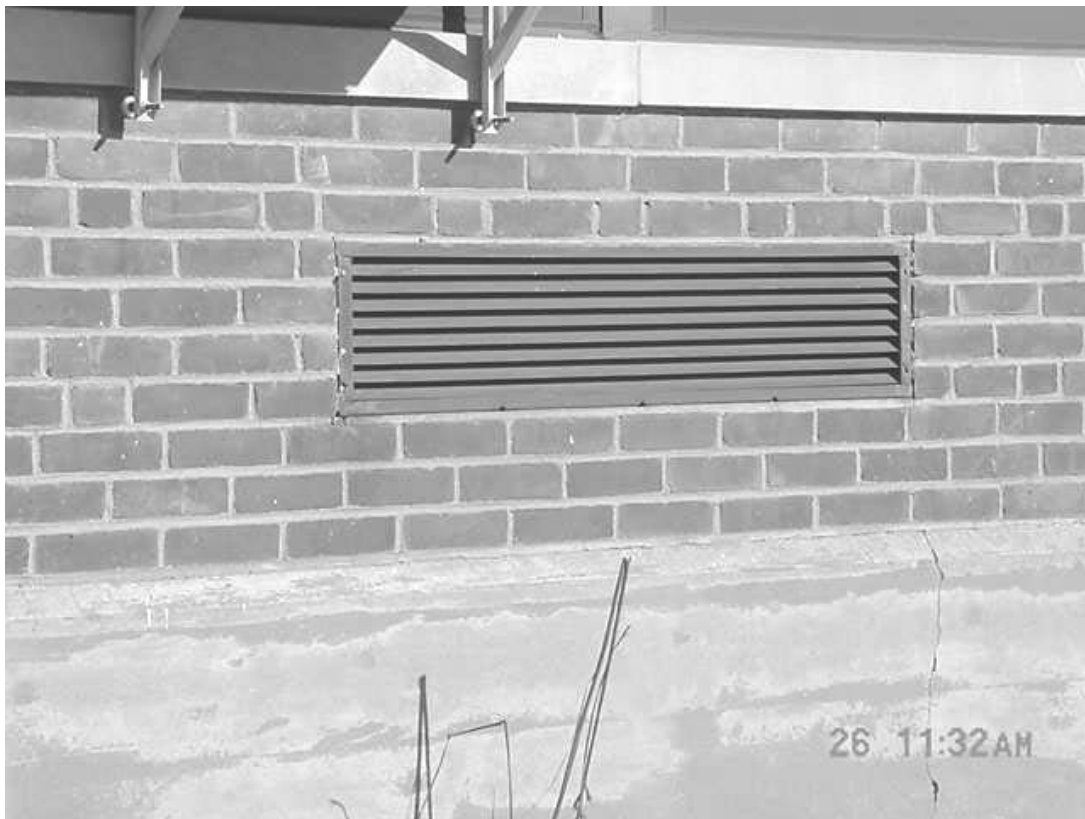
Picture 3

Univent Fresh Air Intake

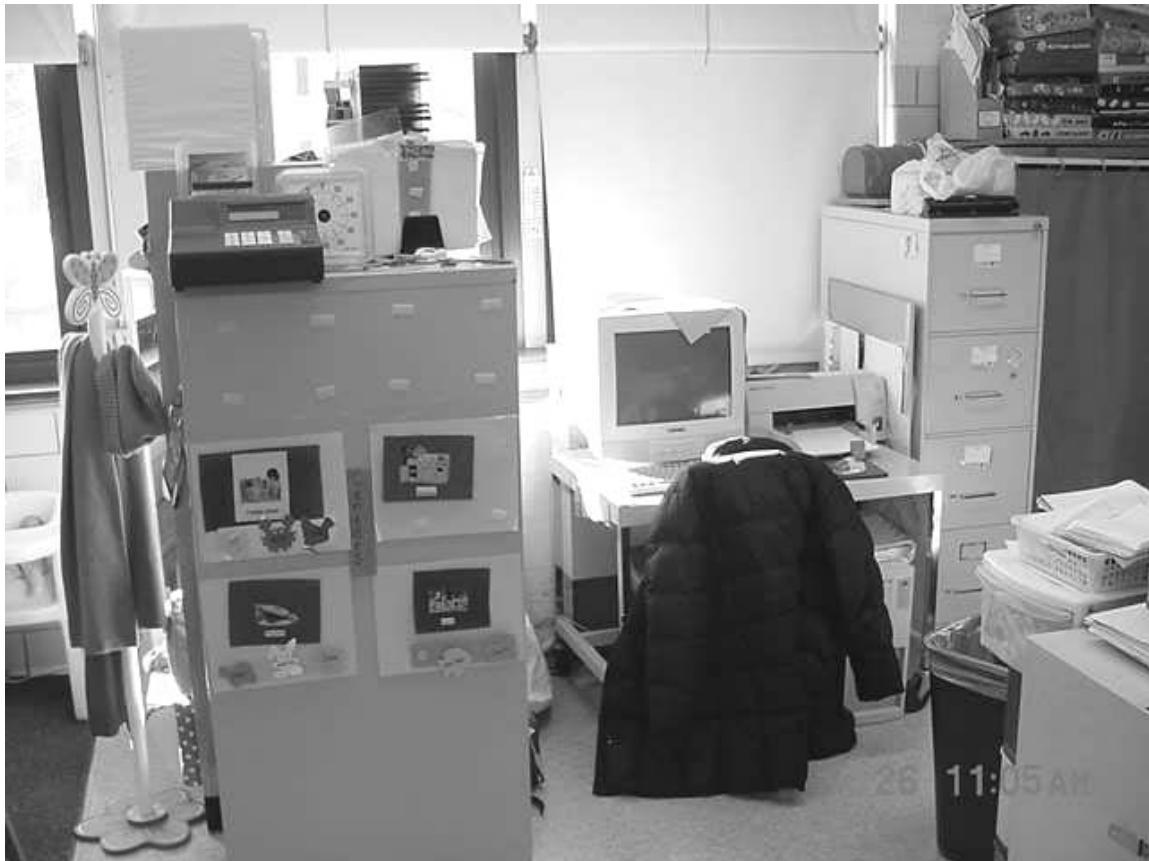
Picture 5

Classroom Furniture and Items Obstructing Univent, Located against Exterior Wall

1. Relocate or provide mechanical ventilation for the speech and PT offices.
2. Remove all blockages from univents and exhaust vents to ensure adequate airflow.
3. Use openable windows in conjunction with classroom univents and exhaust vents to increase air exchange as needed. Care should be taken to ensure windows are properly closed at night and weekends to avoid the freezing of pipes and potential flooding.

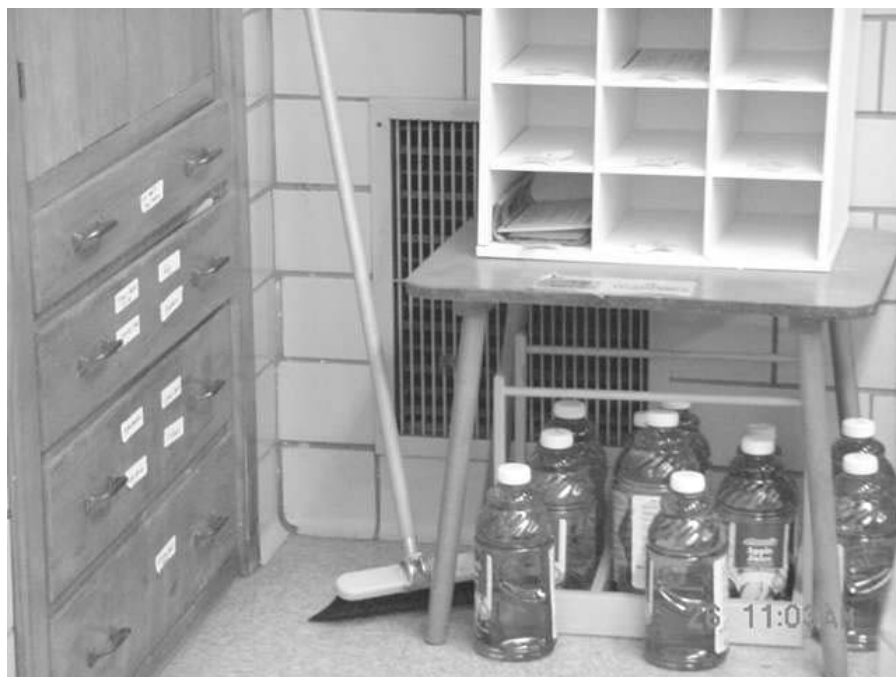
Picture 6

The mechanical exhaust ventilation system in classrooms consists of wall mounted vents (Picture 6) connected to rooftop motors (Pictures 7 and 8). This system was also operating in all areas during the assessment. As with the univents, obstructions to airflow were seen in several classrooms (Picture 6).

Partially Obstructed Exhaust Vent in Classroom

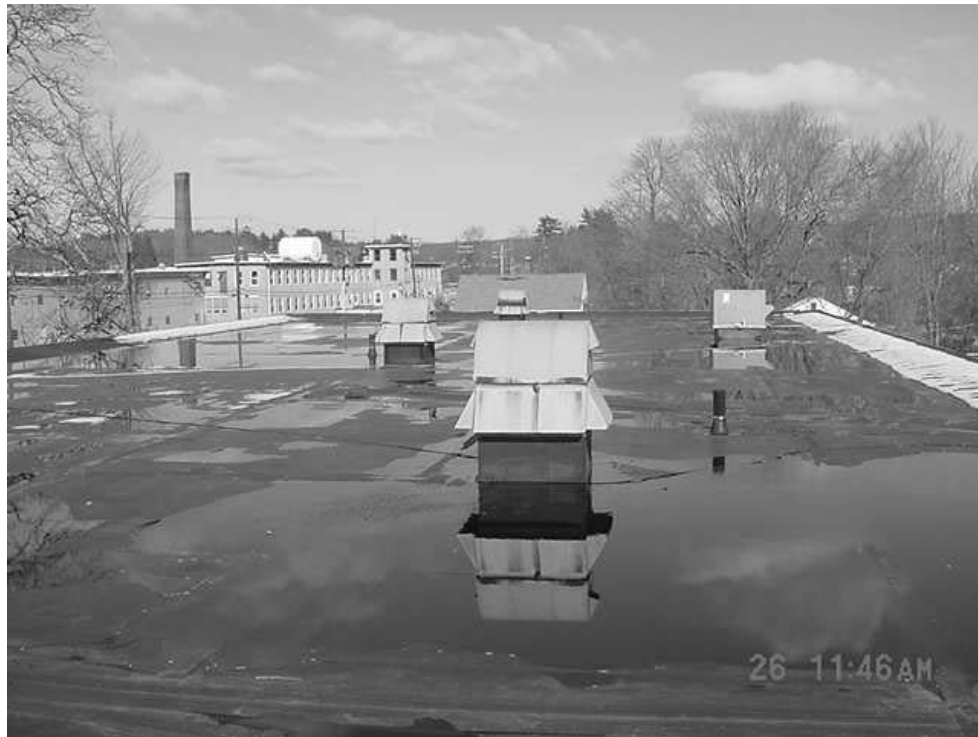
Picture 7

Although the roof was recently repaired, it was not re-graded to improve drainage. MDPH staff observed conditions on the roof and found large areas of pooling water (Pictures 7, 10 and 12). The freezing and thawing of water during winter months can lead to roof leaks and subsequent water penetration into the interior of the building.

Rooftop Exhaust Vents for 1950's Building, also Note Water Pooling on Roof

1. Consider consulting a building engineer about possible options to eliminate water pooling on roof.
2. Consider replacement of fixed ceiling tiles system with a dropped ceiling tile system.
3. Consider contacting an HVAC engineering for an evaluation of ventilation equipment to determine the operability and feasibility of repairing the equipment (as compared to replacing equipment).

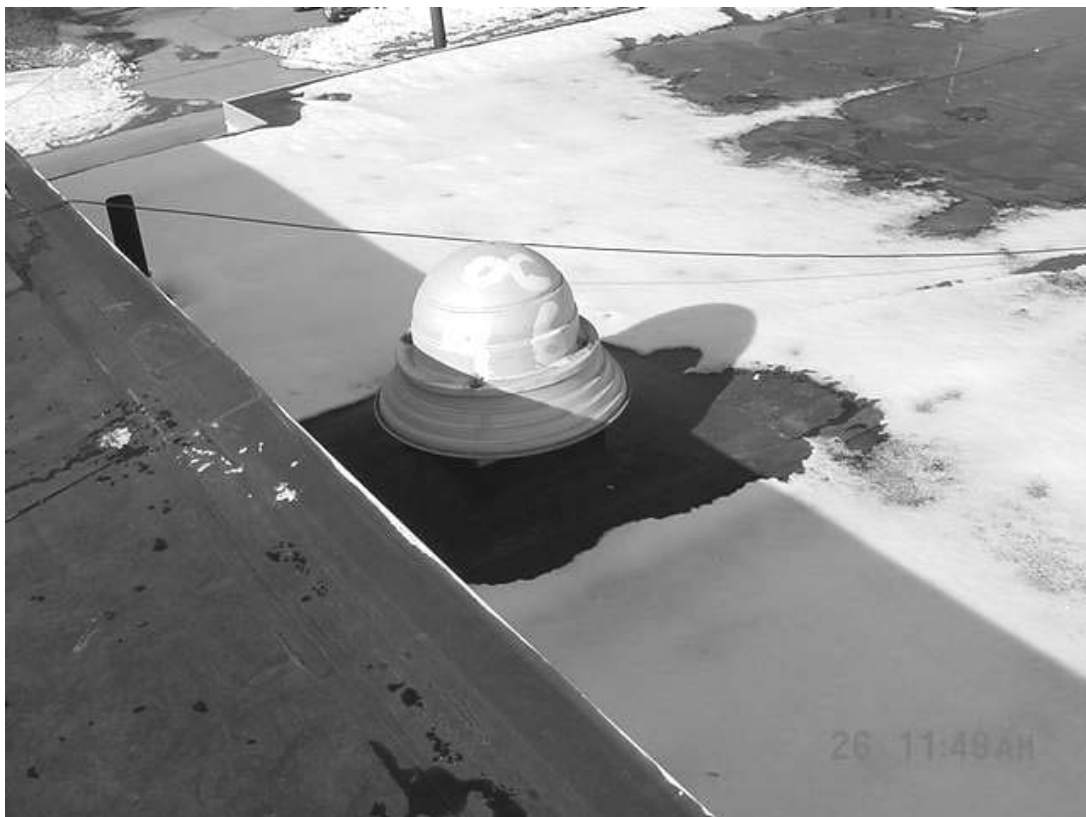
Picture 8

Rooftop Exhaust Vent for 1960's Addition

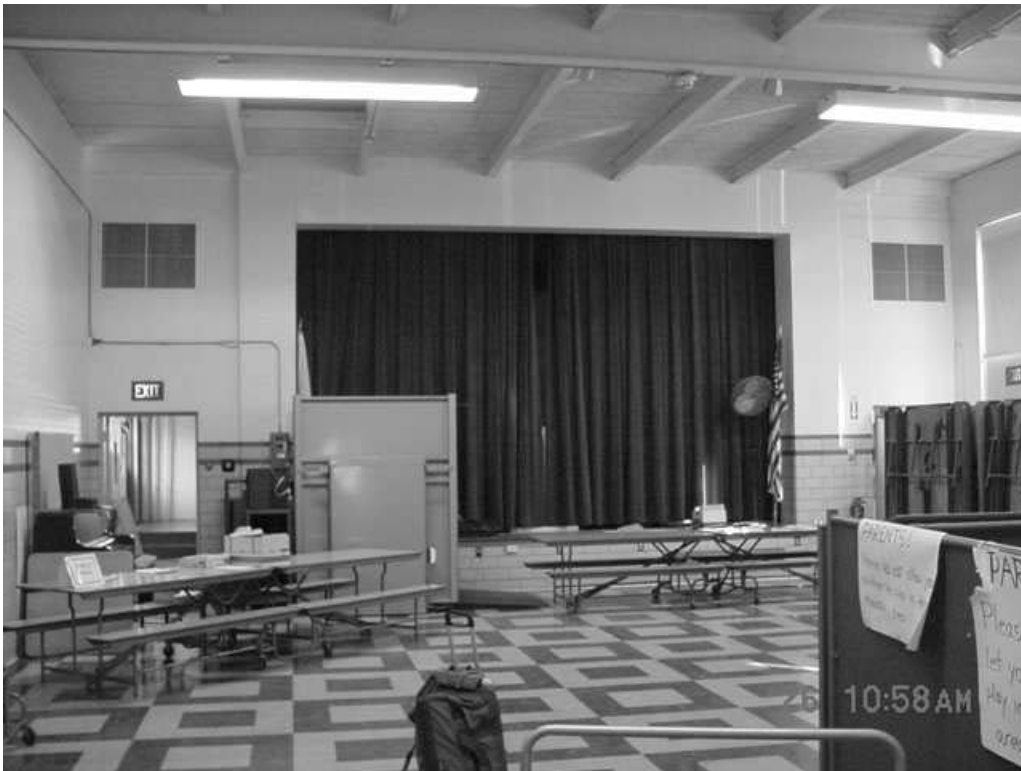
Picture 9

Mechanical ventilation for the former cafeteria, which is currently used as an occupational/physical therapy area, is provided by air handling units (AHUs) located in mechanical rooms on either side of the stage. Fresh air is distributed via wall-mounted supply vents and air is returned to the AHUs through a return vent below the stage (Picture 9). The speech and PT offices are not equipped with mechanical ventilation or openable windows, therefore have no means of air exchange.

Wall-Mounted Supply Vents on Either Side of Stage

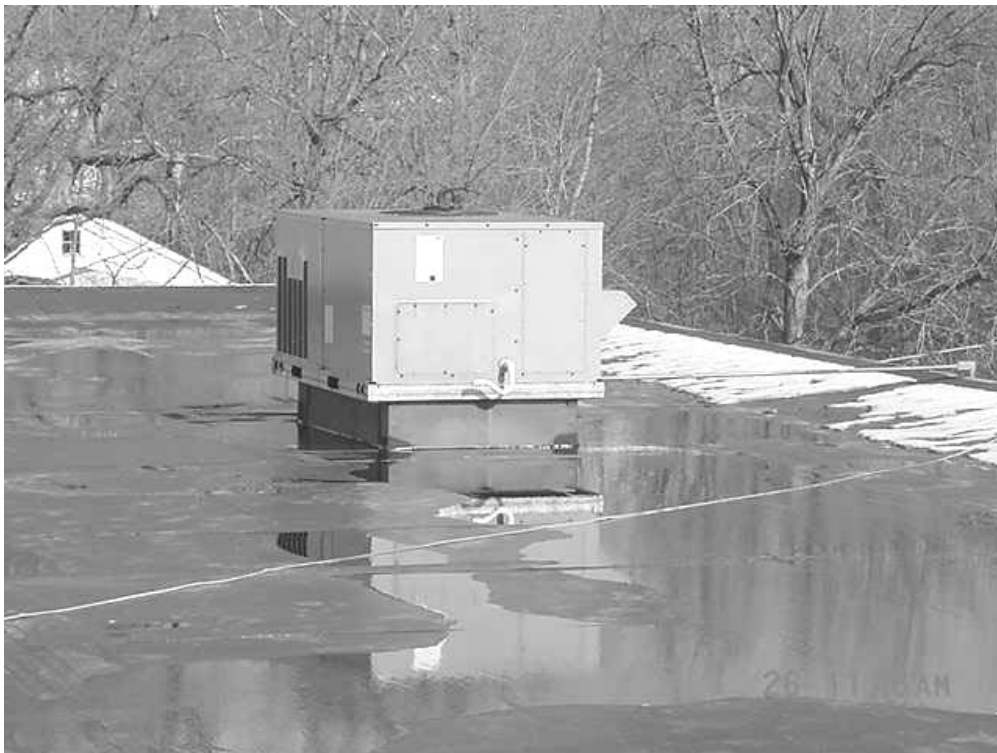
Picture 10

Temperature readings ranged from 69° F to 74° F, with all but one area within the MDPH recommended comfort guidelines during the assessment. The MDPH recommends that indoor air temperatures be maintained in a range of 70° F to 78° F in order to provide for the comfort of building occupants. In many cases concerning indoor air quality, fluctuations of temperature in occupied spaces are typically experienced, even in a building with an adequate fresh air supply. To provide cooling during spring/summer months, the majority of classrooms are equipped with window-mounted air conditioners. Air conditioning for classrooms 3 and 5 is provided by a ducted rooftop AHU (Pictures 10 and 11).

Rooftop AC/AHU for Interior Classrooms, also Note Water Pooling on Roof

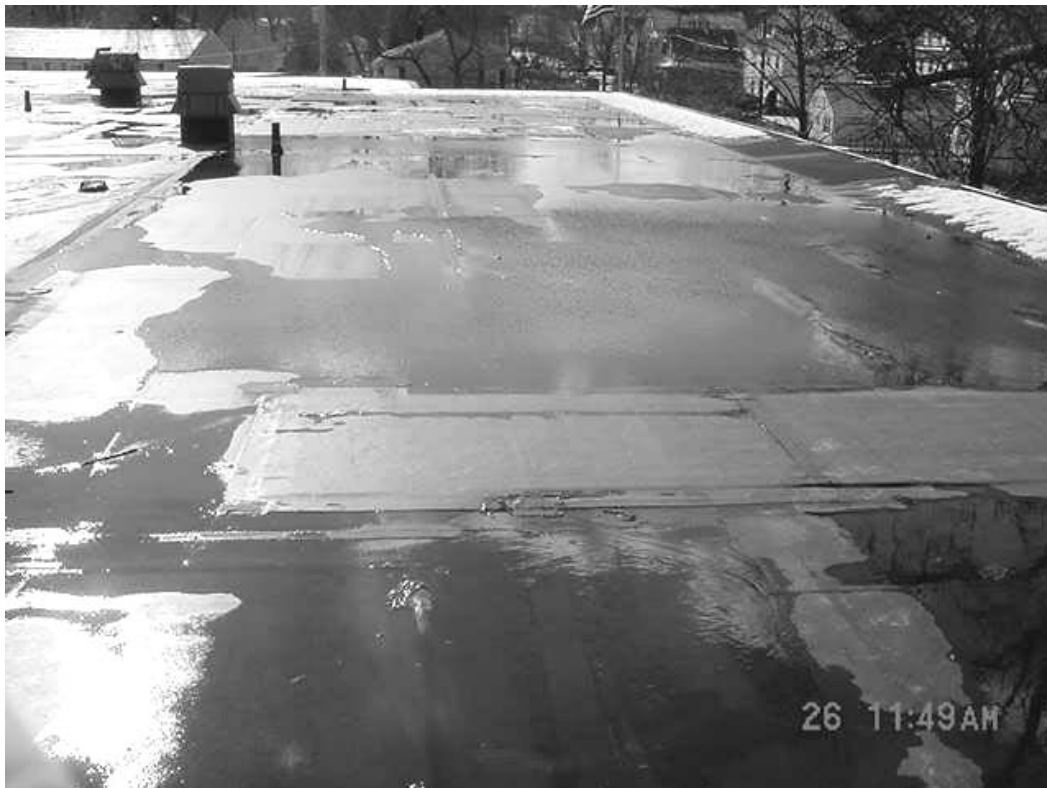
Picture 12

Large Areas of Water Pooling on Roof

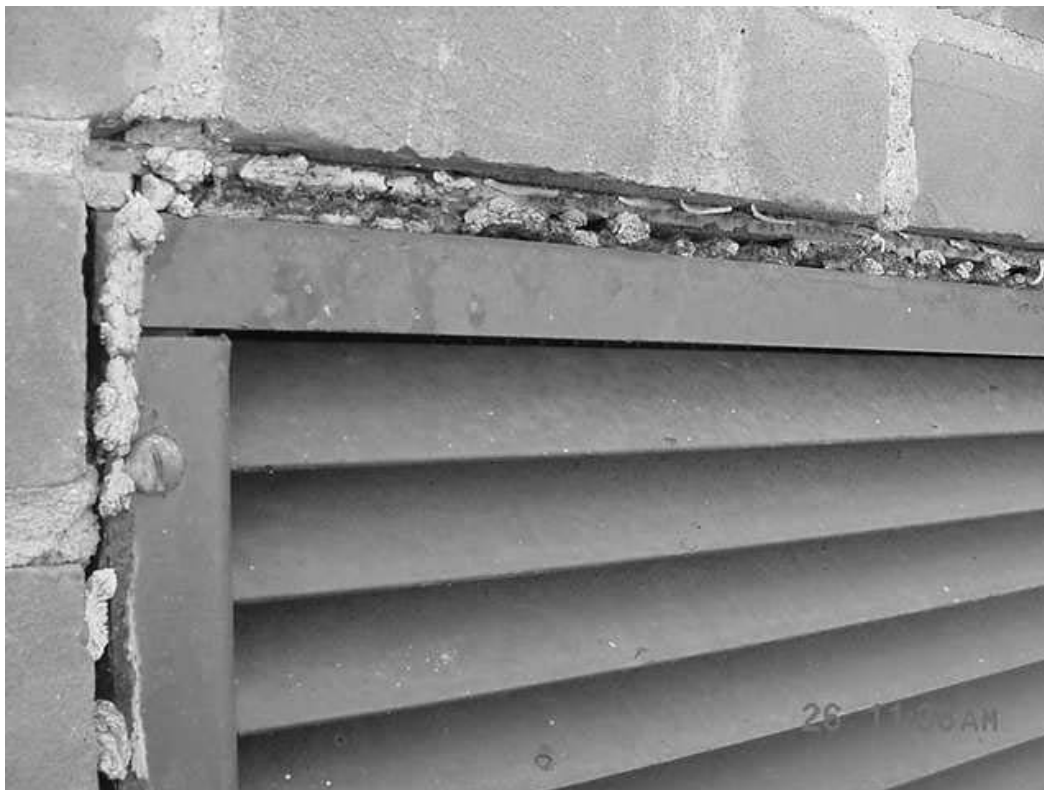
Picture 13

Another potential pathway for water penetration into the building is around univent air intakes on the exterior of the building. Missing/damaged caulking was observed around univent air intakes (Picture 13). Repeated water penetration can result in the chronic wetting of building materials and potentially lead to microbial growth. In addition, these breaches may provide a means of egress for pests/rodents into the building.

Missing/Damaged Caulking around Univent Fresh Air Intakes

6. Avoid over-watering of plants and examine drip pans periodically for mold growth. Disinfect with an appropriate antimicrobial where necessary.
7. Seal breaches around univent fresh air intakes to prevent water penetration, drafts and pest entry.

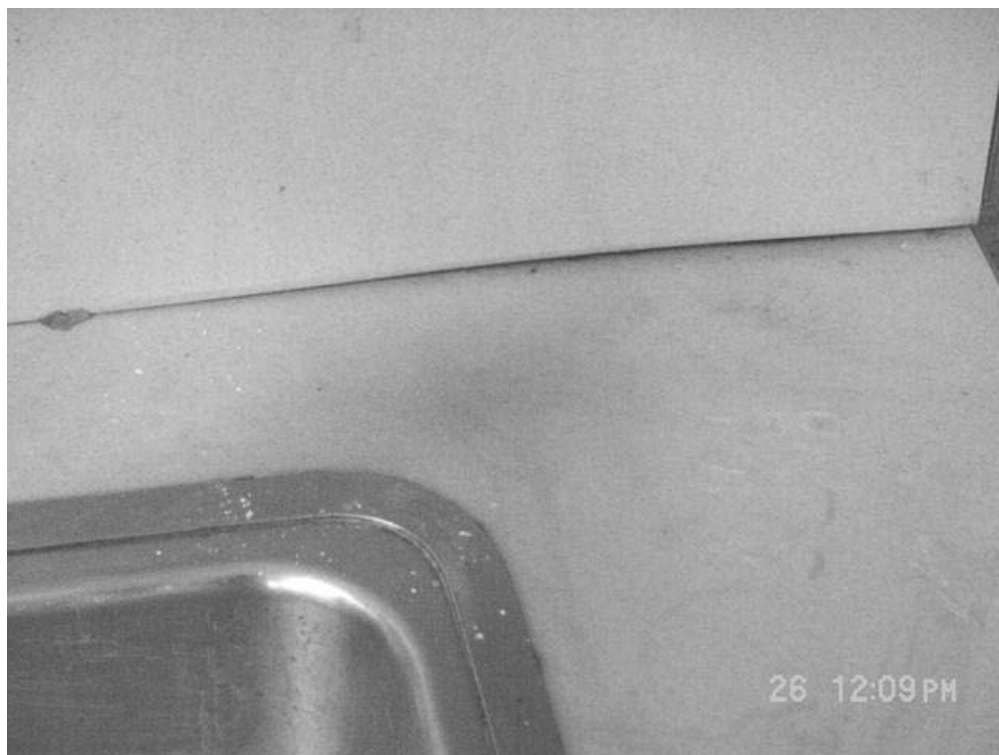
Picture 14

Spaces between the sink countertop and backsplash were seen in a few classrooms (Table 1/Picture 14). Improper drainage or sink overflow can lead to water penetration of countertop

wood, the cabinet interior and areas behind cabinets. Like other porous materials, if these materials become wet repeatedly, they can provide a medium for mold growth.

Spaces between Sink Countertop and Backsplash

8. Seal breach or replace damaged section of exhaust ductwork for the water heater (Pictures 15 and 16).
9. Seal areas around sinks to prevent water-damage to the interior of cabinets and adjacent wallboard. Inspect wallboard for water damage and mold growth, repair/replace as necessary. Disinfect areas with an appropriate antimicrobial, as needed.

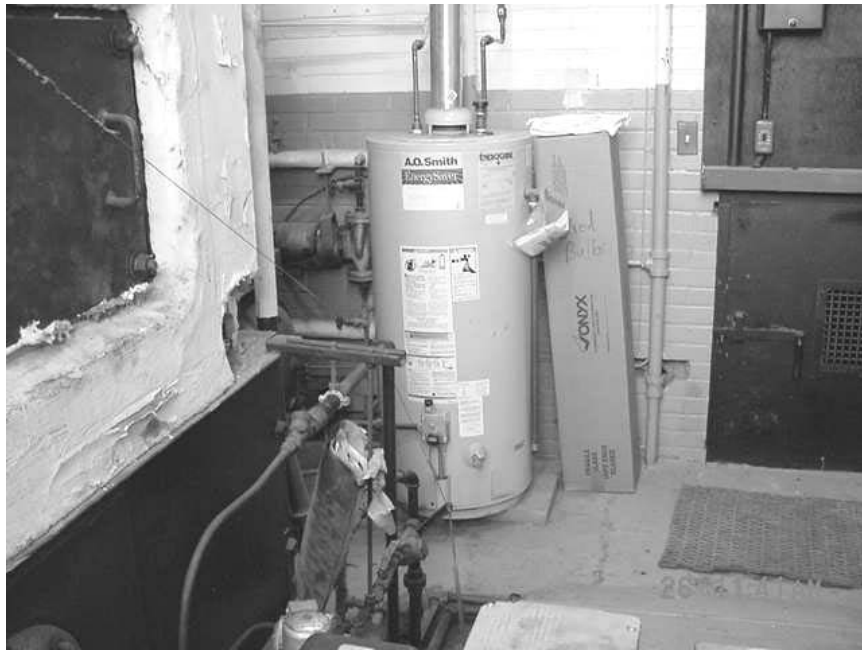
Picture 15

Carbon monoxide should not be present in a typical, indoor environment. If it is present, indoor carbon monoxide levels should be less than or equal to outdoor levels. For the ELC, indoor carbon monoxide concentrations were non-detect or ND (Table 1). Carbon monoxide levels measured outside the school were also ND (Table 1). Although no measurable levels of carbon monoxide were detected, a potential source was identified outside the boiler room. During a perimeter inspection of the building MDPH staff observed a breach in the exhaust ductwork for the hot water heater (Pictures 15 and 16). This section of ductwork should be repaired to ensure proper removal of exhaust emissions.

Water Heater in Boiler Room

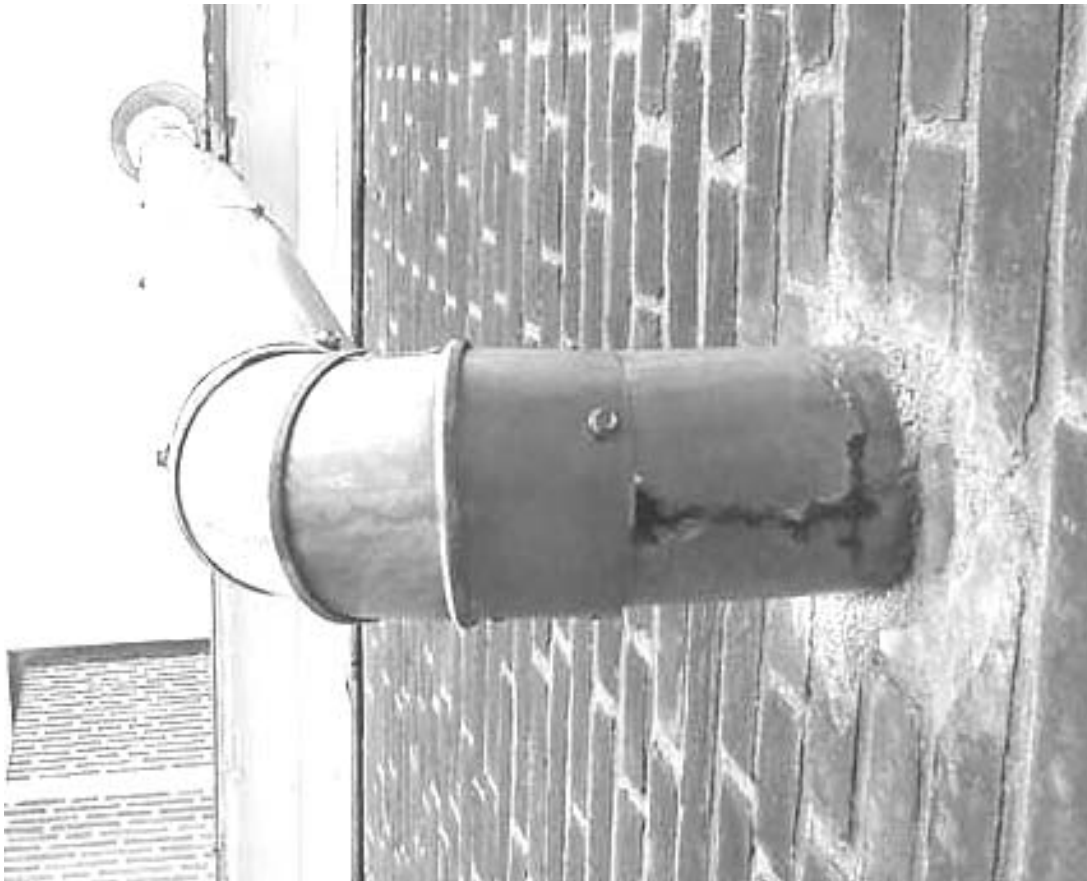
Picture 16

Breach in Bottom of Water Heater Exhaust Duct
